## **Clay Masonry Arch Project**

ARE 4280 Masonry Design

December 15, 2005

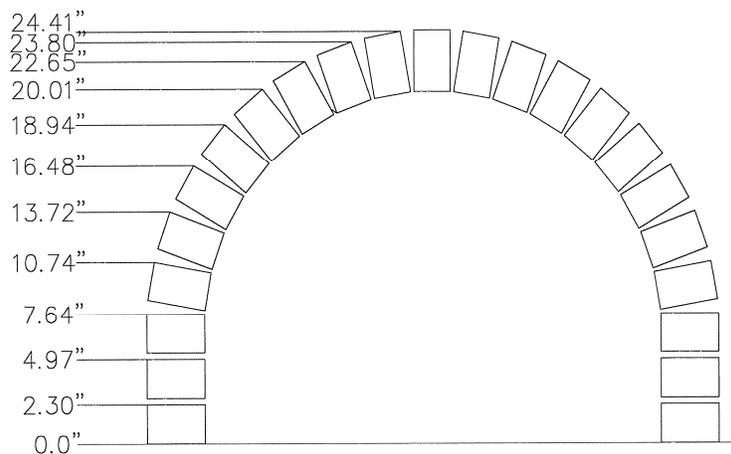
Figure 3. Masonry Arch Construction Detail

Prior to testing, it was predicted the arch would fail at one of the mortar joints next to the brick at the peak, or keystone, and at the joint between the third and fourth or at 7.63 in. shown in Figure 3. We concluded to this guess because the keystone would endure the most stress in the arch therefore that joint would break. The joint at 7.64 in., shown in Figure 3, would fail because the bottom three courses were vertical and by the fourth course the bricks started to rotate to begin the arch pattern. Therefore, it would fail due to initial displacement during testing.

During the testing, the arch developed additional joint separation at the 7.64 in. joint on both sides of the arch and the 18.34 in. joint on one side, see Figure 3. After the separation in the joints of the arch, the bricks were resisting against the reaction frames of the actuator shown in Figure 5. Finally, the arch could no longer support anymore load and failed completely.

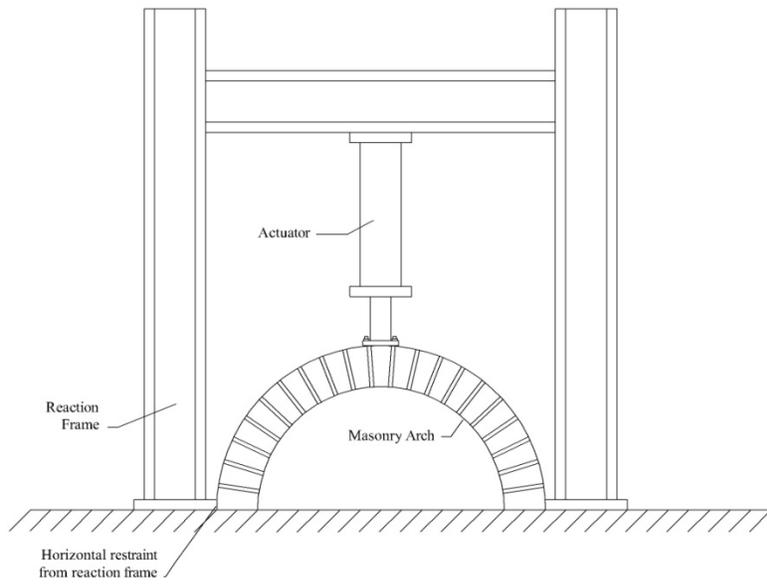
Figure 5. Loading Frame

The arch was removed from the jig and placed in the loading frame of the servo-controlled actuator as shown in Figure 5. The arch was tested as a beam with the piston pressing down at the peak, or midspan, as the legs of the arch were supported by the testing room floor. The load of the piston was set at 0.05 inches/minute until critical failure.

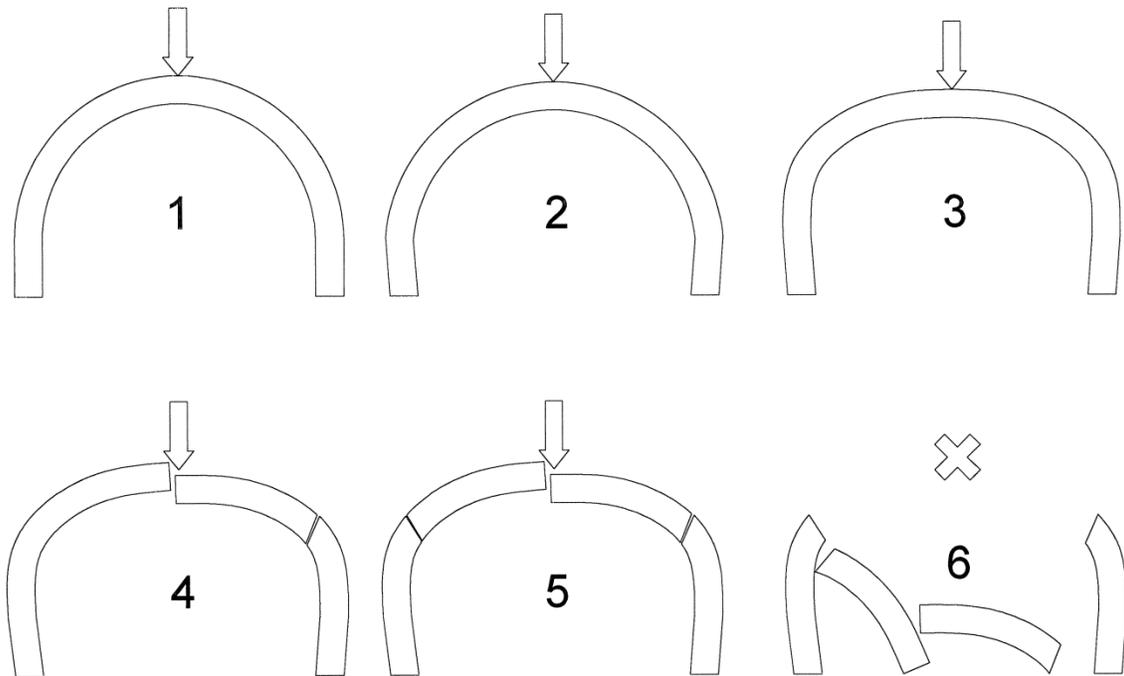
Figure 6. Force-Displacement Diagram

During the testing procedure, the arch underwent an imposed displacement creating a force. In Figure 5.1, the process began to take place and a load was applied. At first, no displacement was seen. In Figure 5.2, displacement began to occur. The most noticeable displacement was a rotation at the base of the arch as well as a downward displacement at the middle (keystone). As the arch was further tested (Figure 5.3) an outward projection was seen due to a deeper displacement of the middle, and further rotation of the base. Figures 5.4 and 5.5 show where cracking occurred due to the intense stress in the mortar joints at the critical locations. Eventually the displacement and force was great enough to fail the arch.

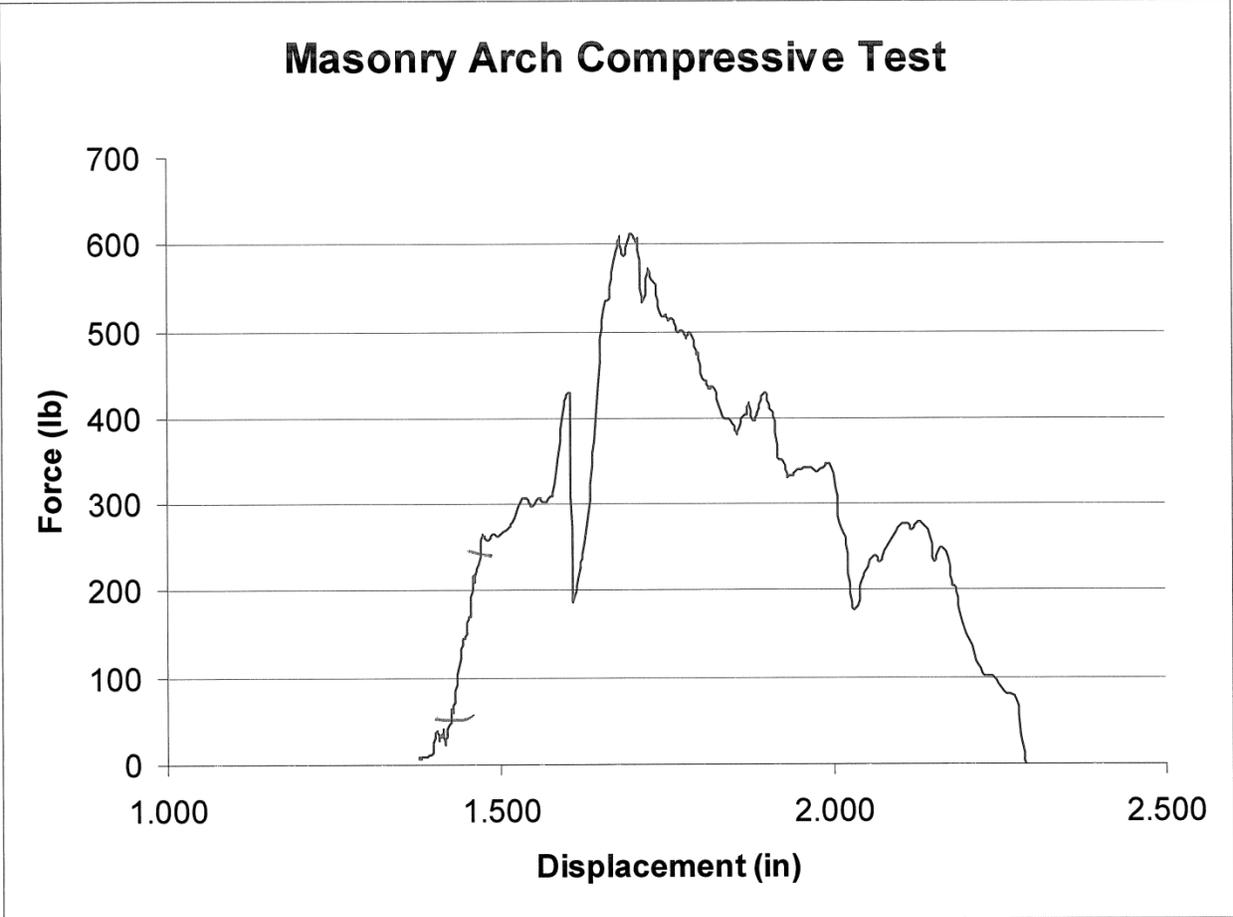
Figure 7. Force-Displacement Graph

We estimated the elastic portion of the test to be between the points (1.468, 240.53) and (53.121, 1.423). This is the most linear portion of the graph and the most accurate measurement could be made. The calculation for the stiffness is shown below:

$$\text{Stiffness} = \frac{240.53 \text{ lb} - 53.121 \text{ lb}}{1.468 \text{ in} - 1.423 \text{ in}} = 4164 \text{ lb/in}$$
