Clay Masonry Arch Project

ARE 4280 Masonry Design

December 15, 2005

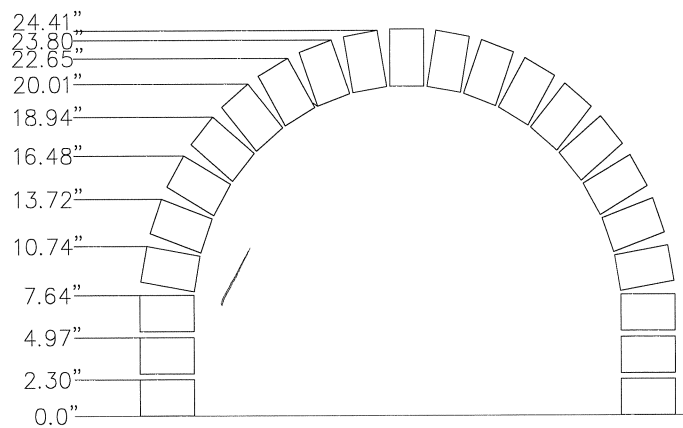
Figure 3. Masonry Arch Construction Detail

Prior to testing, it was predicted the arch would fail at one of the mortar joints next to the brick at the peak, or keystone, and at the joint between the third and fourth or at 7.63" shown in Figure 3. We concluded to this guess because the keystone would endure the most stress in the arch therefore that joint would break. The joint at 7.64", shown in Figure 3, would fail because the bottom three courses were vertical and by the fourth course the bricks started to rotate to begin the arch pattern. Therefore, it would fail due to initial displacement during testing.

During the testing, the arch developed additional joint separation at the 7.64" joint on both sides of the arch and the 18.34" joint on one side, see Figure 3. After the separation in the joints of the arch, the bricks were resisting against the reaction frames of the actuator shown in Figure 5. Finally, the arch could no longer support anymore load and failed completely.

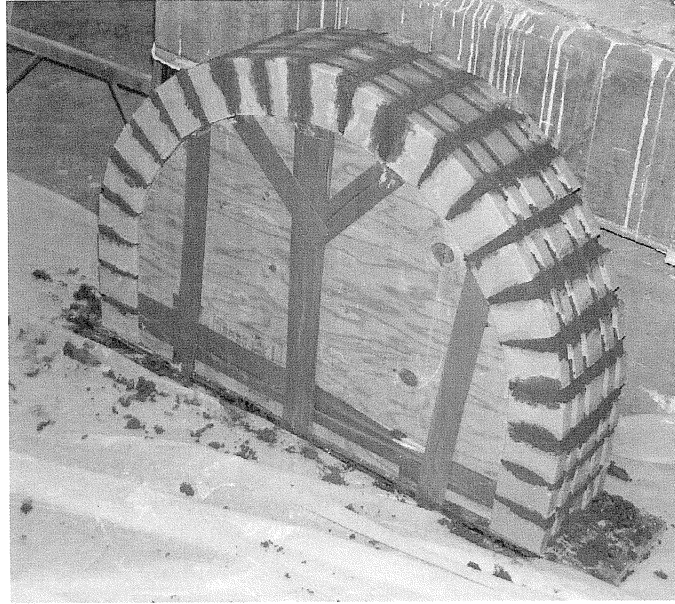
Figure 4. Constructed Clay Masonry Arch

Before the testing began, a shrinkage crack was found at the joint next to the keystone brick. As the mortar was curing over a thirty day period, the arch began to shrink. Consequently, the jig prevented the arch from shrinking, thus a shrinkage crack was formed.

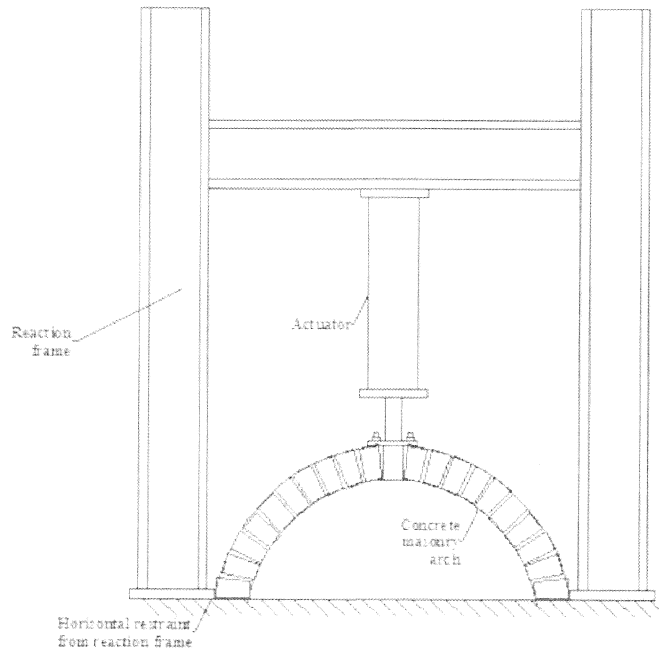
Figure 5. Loading Frame

The arch was removed from the jig and placed in the loading frame of the servocontrolled actuator as shown in Figure 5. The arch was tested as a beam with the piston pressing down at the peak, or midspan, as the legs of the arch were supported by the testing room floor. The load of the piston was set at 0.05 inches/minute until critical failure.

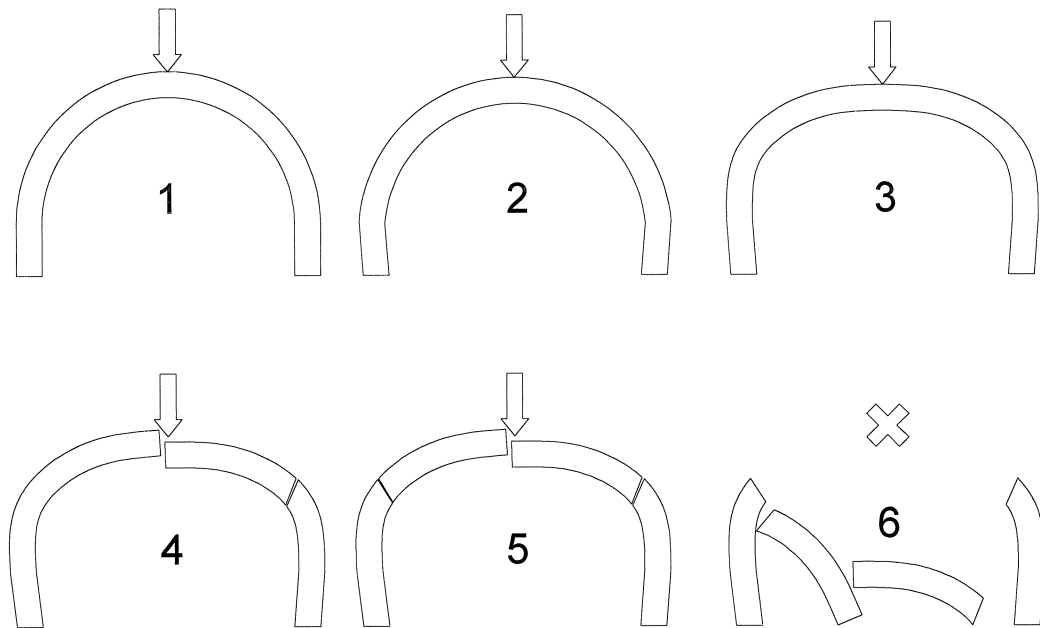
Figure 5. Force-Displacement Diagram

During the testing procedure, the arch underwent a displacement due to an imposed force. In figure 5.1, the process began to take place and a load was applied. At first, no displacement was seen. In Figure 5.2, displacement began to occur. The most noticeable displacement was a rotation at the base of the arch as well as a downward displacement at the middle (keystone). As the arch was further tested (Figure 5.3) an outward projection was seen do to a deeper displacement of the middle, and further rotation of the base. Figures 5.4 and 5.5 show where cracking occurred due to the intense stress in the mortar joints at the critical locations. Eventually the displacement and force was great enough to fail the arch.

Our arch behaved very similarly to our anticipated behavior. We knew that the arch would fail in compression and that there would be a slight “bowing” of the structure in general. We did not anticipate cracks forming on either side of the arch. We had originally thought that it would fail in the center of the arch in the mortar joints. However, as shown in figure 5.5 two cracks formed on either side of the arch, causing it to fail.

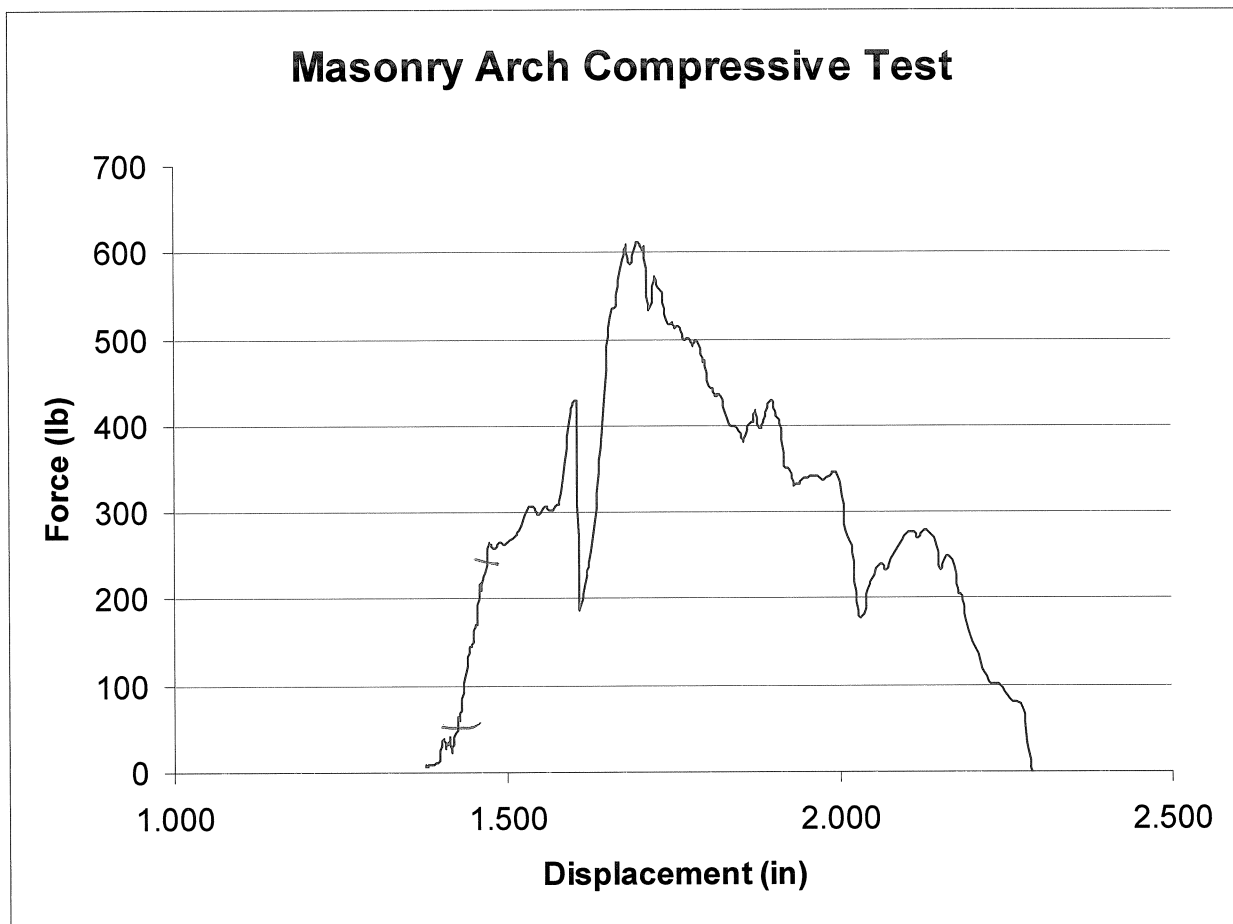
Figure 6. Force-Displacement Graph

We estimated the elastic portion of the test to be between points (1.468 , 240.53) and (53.121 , 1.423). This is the most linear portion of the graph and the most accurate measurement could be made. The calculation for the stiffness is shown below:

$$\text{Stiffness} = \frac{240.53 \text{ lb} - 53.121 \text{ lb}}{1.468 \text{ in} - 1.423 \text{ in}} = 4164 \text{ lb/in}$$
