## **Clay Masonry Arch Project**

ARE 4280 Masonry Design

December 15, 2005

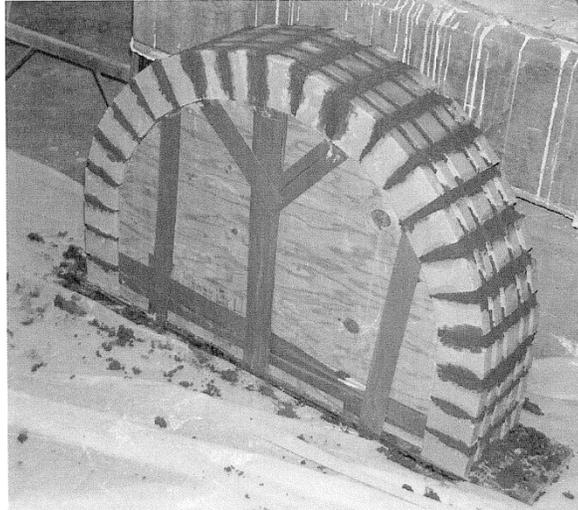
Figure 4. Constructed Clay Masonry Arch

Before the testing began, a shrinkage crack was found at the joint next to the keystone brick. As the mortar was curing over a 28-day period, the arch began to shrink. Consequently, the jig prevented the arch from shrinking, thus a shrinkage crack was formed.

During the testing, the arch developed additional joint separation at the 7.64 in. joint on both sides of the arch and the 18.34 in. joint on one side, see Figure 3. After the separation in the joints of the arch, the bricks were resisting against the reaction frames of the actuator shown in Figure 5. Finally, the arch could no longer support anymore load and failed completely.
